NARRAGANSETT BAY BASIN  
WEST WARWICK, RHODE ISLAND  
**ARCTIC DAM**  
**RI 03802**

PHASE I INSPECTION REPORT  
NATIONAL DAM INSPECTION PROGRAM

JANUARY 1981

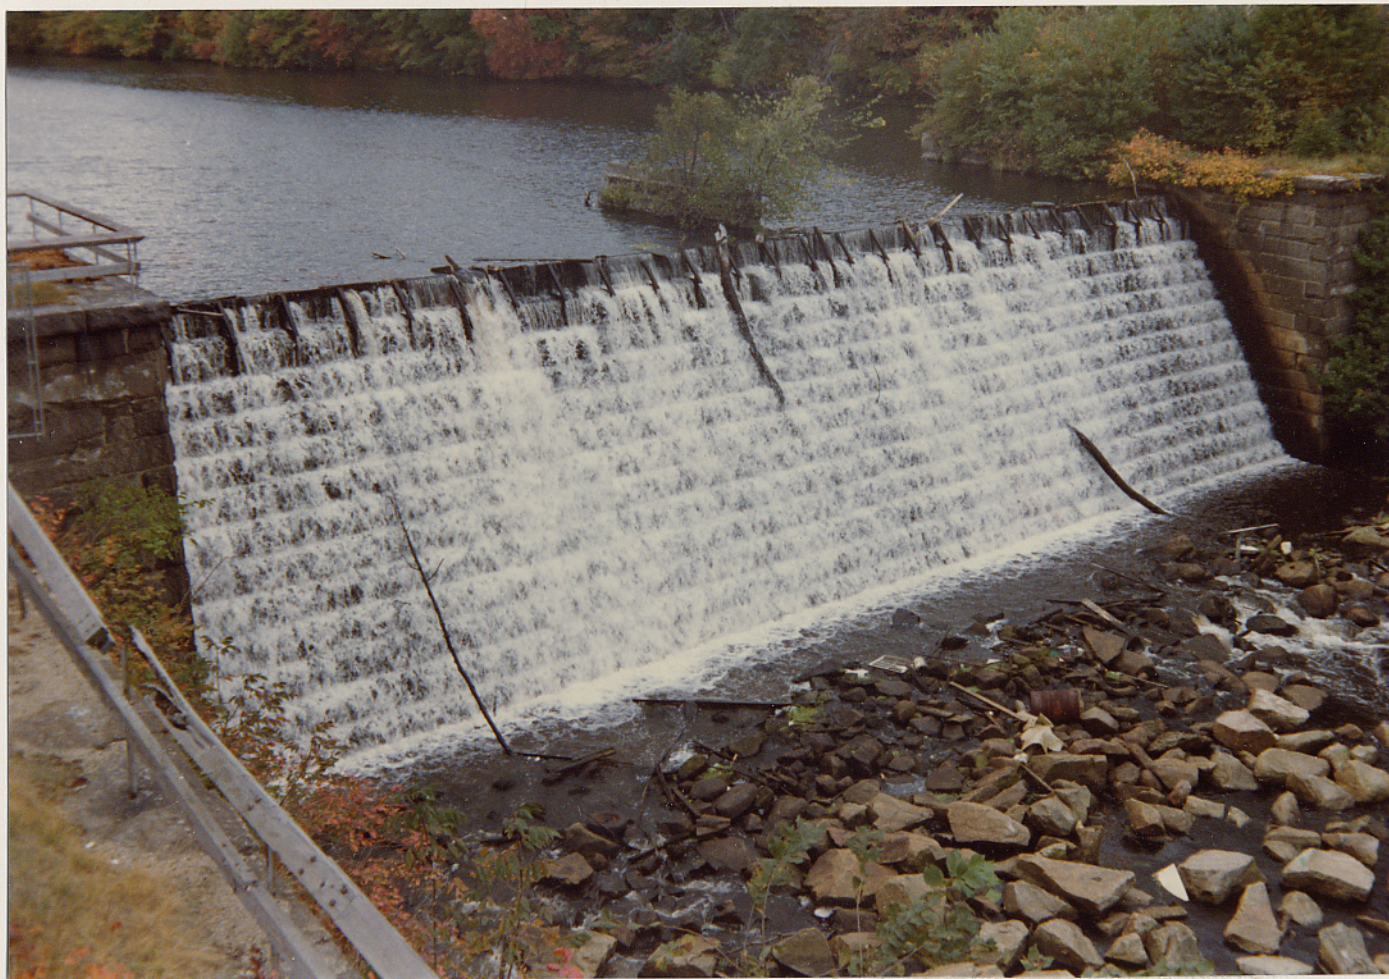
OVERVIEW PHOTO

The top of the left non-overflow section is in poor condition with a dense growth of small trees, saplings and underbrush and several footpaths due to trespassing (Overview Photo).

5. Repair or replacement of the low-level outlet gate and gate hoisting mechanism.
6. Repair of undermined areas of the masonry wall along the right side of the downstream channel.
7. Removal of all trees from the dam and from within 10 feet of the toe of the dam, including proper backfilling with selected material.

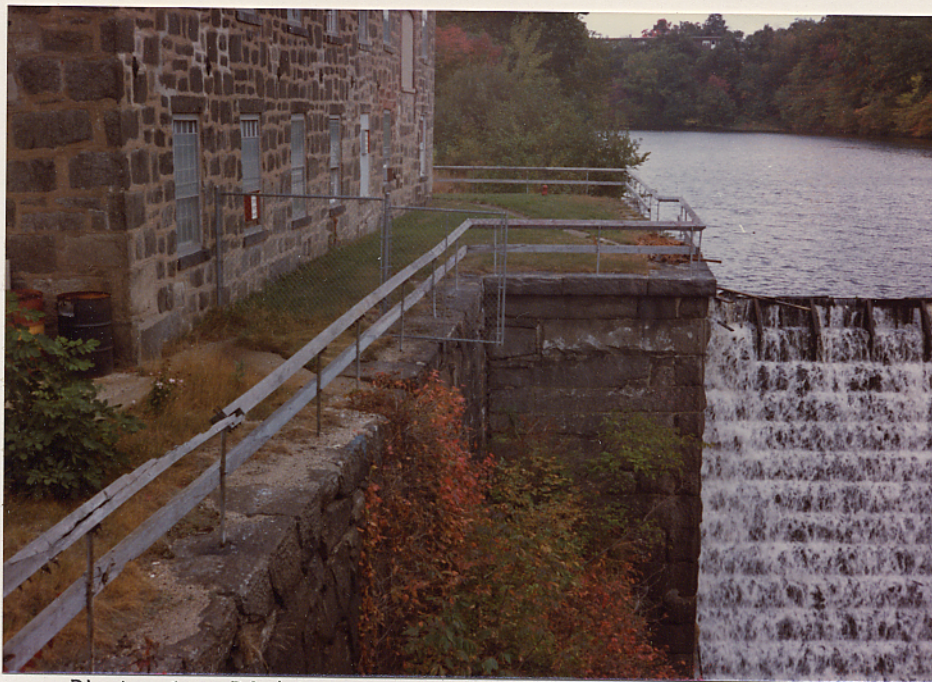
Top of Dam - The top of the right non-overflow section is in good condition, with a regular surface and good grass cover (Photo 1). A wooden railing on top of the masonry wall and extending from the upstream edge of the dam to the bridge 100 feet downstream of the dam is in fair condition, with slight rotting of the wood.

Photo 1 - Right non-overflow section of dam and adjacent factory building (10/8/80).

9. The rotted wooden railing along the top of the right non-overflow section should be repaired.

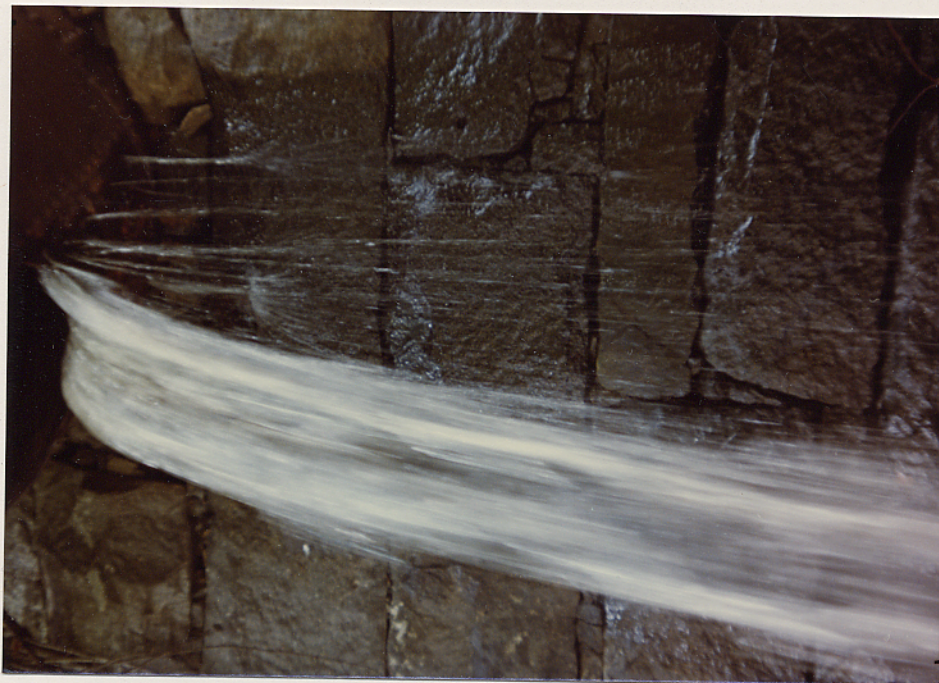
The downstream face of the left section is in poor condition. In the area beneath the low-level outlet pipe, mortar has been almost totally leached out of the joints in the masonry (Photo 2). This appears to be caused by leakage from the pipe onto the outside of the wall, rather than by seepage from the body of the dam through the wall. A clump of small trees, the roots of which may extend through the masonry face into the body of the dam, is growing on top of the outlet pipe where it exits from the dam. Other than in the area of the outlet pipe, the downstream face appears to be in good condition, although the toe is obscured by branches and debris.

8. If the low-level outlet gate is inoperable, it prevents lowering of the upstream water level should the need occur.
9. Continued rusting of the low-level outlet pipe along with possible leakage of the outlet gate could cause water to leak from the pipe into the body of the dam, possibly causing internal erosion of the dam.

Photo 2 - Downstream end of low-level outlet pipe. Note deterioration of pipe and leached-out mortar joints on wall (10/8/80).

1. A detailed hydraulic/hydrologic analysis to determine the adequacy of the project discharge capacity and overtopping potential.
2. Inspection of the downstream face and toe of the spillway section with the upstream water level just below the spillway crest.
3. Inspection of the inside of the 48 inch steel low-level outlet pipe, determination of the source of leakage through the pipe, and repair or replacement of the pipe.
4. Determination of the cause of leaching of the mortar from joints in the masonry, particularly near the low-level outlet pipe's exit from the downstream face of the dam and repair of the mortar joints.

7. Leached or cracked mortar joints on the dam and appurtenant structures should be repaired and maintained as part of normal maintenance procedures at the site.

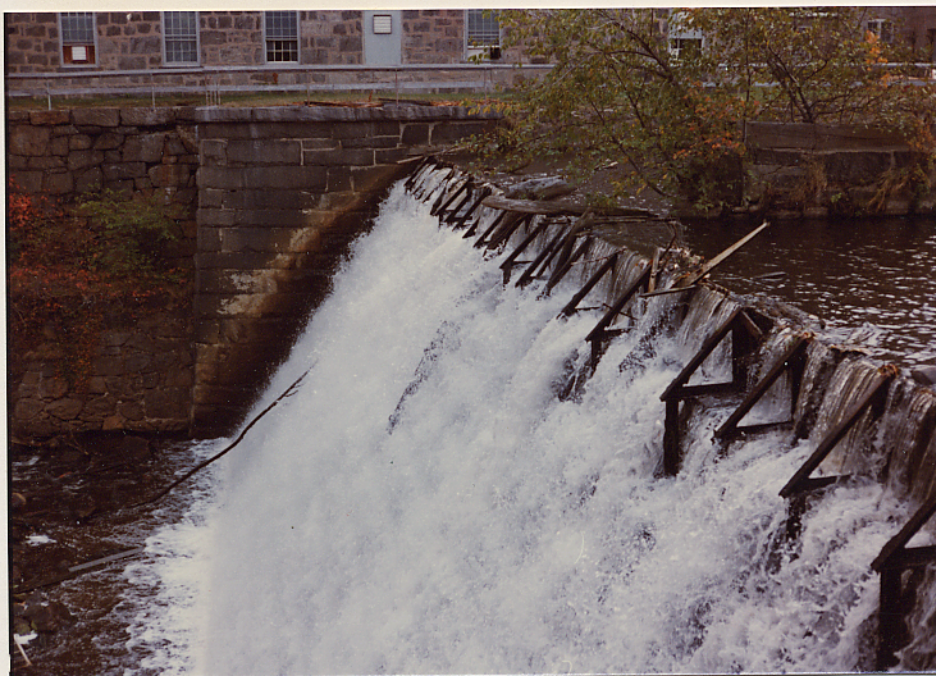
Spillway - Although it appears to be in good condition, flow over the spillway prevented close inspection of the downstream face and toe. No irregularities of the tiered downstream face were noted and the abutments with the non-overflow sections appeared good, except for some leaching of mortar due to contact with water going over the spillway. The masonry spillway crest appears to be in good condition, but the stop planks are somewhat leaky and deteriorated. The stop plank supports, though rusted on the outside, do not show any significant deterioration. Also, at approximately 4 feet apart, they are closely spaced, and all are in

Photo 3 - Downstream face of spillway, spillway crest with permanent stop planks, and bridge pier in approach channel (10/8/80).

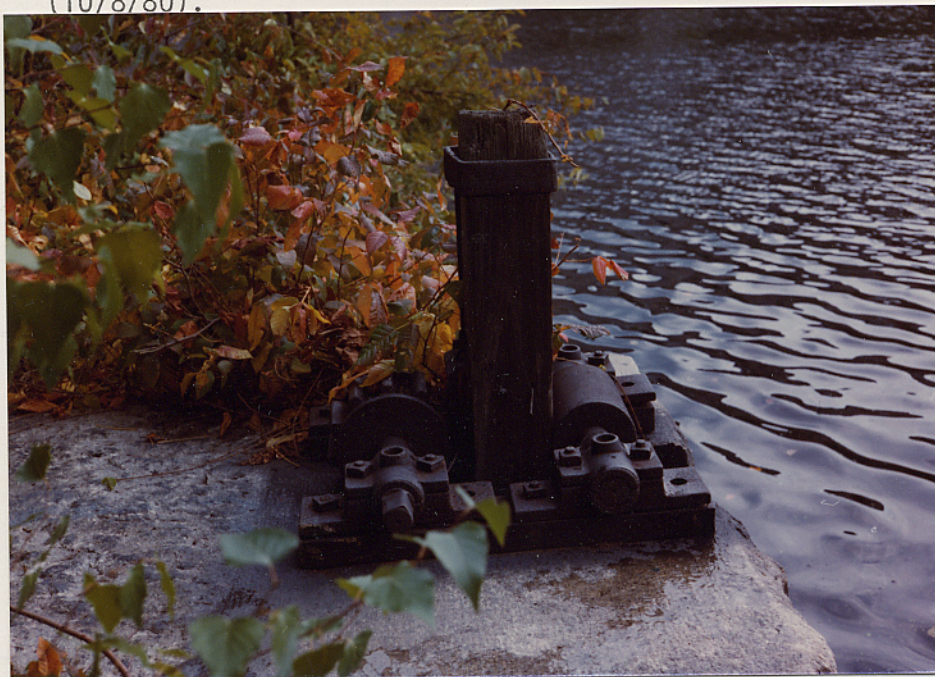
c. Appurtenant Structures - The operability of the low-level outlet gate for the dam is questionable and the 48 inch steel low-level outlet pipe appears to be in poor condition. The control mechanism, a rack-with-pinion gate hoist mounted on the upstream wall of the left non-overflow section, is rusted and the wood gate support is rotting (Photo 4). The handle for the control mechanism is not in place and the owner is not sure of its location. Approximately 200 gallons per minute (gpm) or more were flowing from the downstream end of the low-level outlet pipe (Photo 2), indicating that either the gate leaks or that it is not tightly closed, or possibly that there is seepage from the body of the dam into the pipe. Observed from its downstream end, the pipe is in poor condition. Although it protrudes approximately 5 feet out from the downstream face of the dam, extensive corrosion of the bottom of the pipe allows some of the flow through the pipe to be discharged onto the masonry face of the dam, causing leaching of the mortar. Also, as previously mentioned, there is a clump of small trees growing on top of the pipe at its point of exit from the dam.

Photo 4 - Rack-with-pinion gate hoisting mechanism (10/8/80).

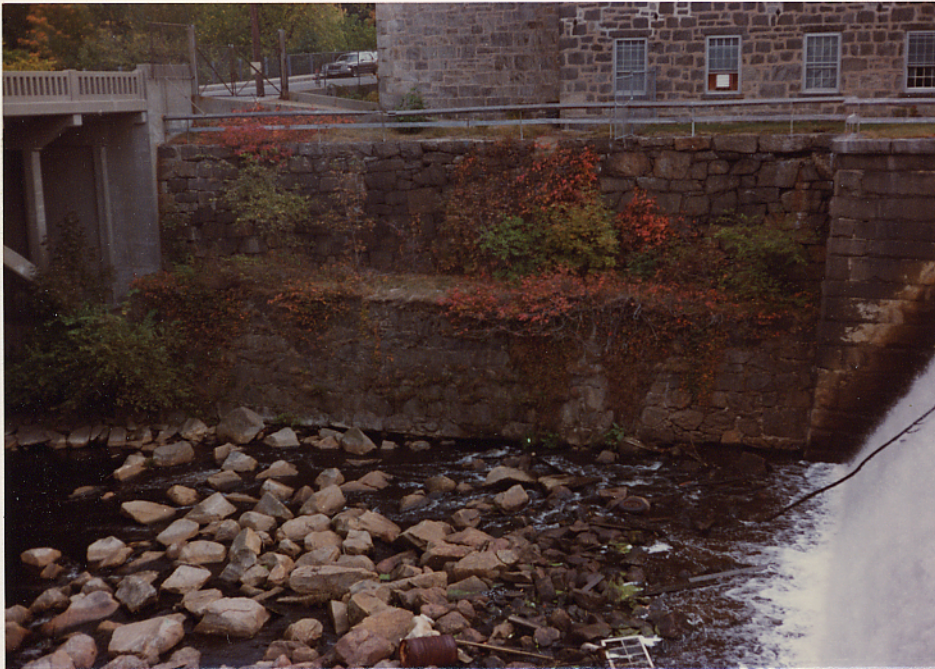
Photo 5 - Benched channel bank retaining wall between arch bridge at left and dam at right (10/8/80).

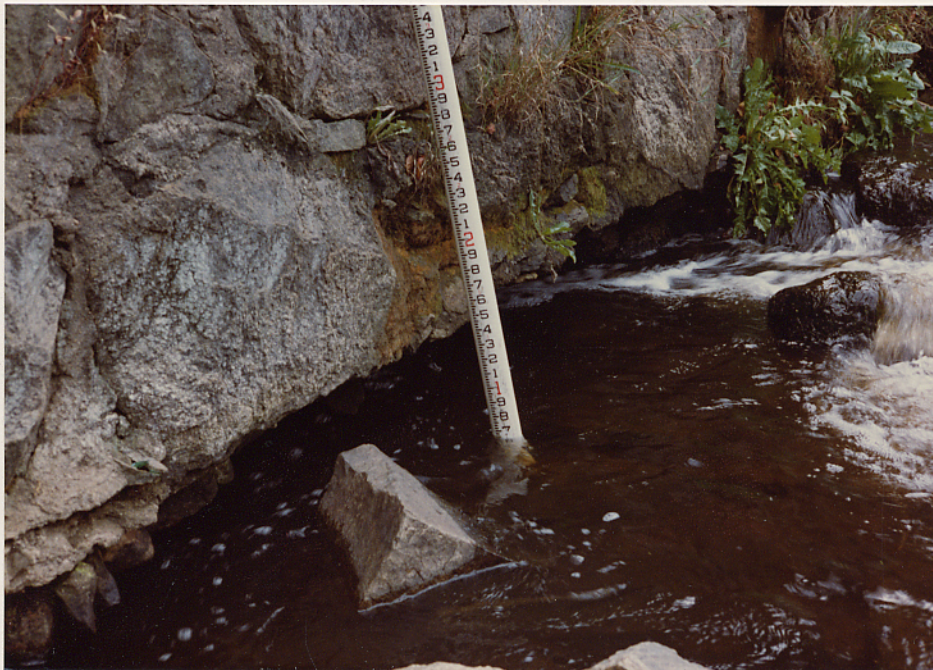
10. The roots of brush and trees growing from the walls on each side of the downstream channel could cause displacement of masonry.
11. Undermining of the masonry wall along the right side of the downstream channel could threaten the stability of this wall.

Photo 6 - Undermining at base of retaining wall. Note depth of flow and pattern of current under wall (10/8/80).
